# Selling Arguments *for* TIN ROOFING

*A review of the advantages of  
roofs of this type*

A textbook containing corrected tables for use in estimating, instructions for laying tin roofs, description of the manufacture of roofing tin, and a large amount of information useful to the practical man.

N. & G. Taylor Company, Philadelphia

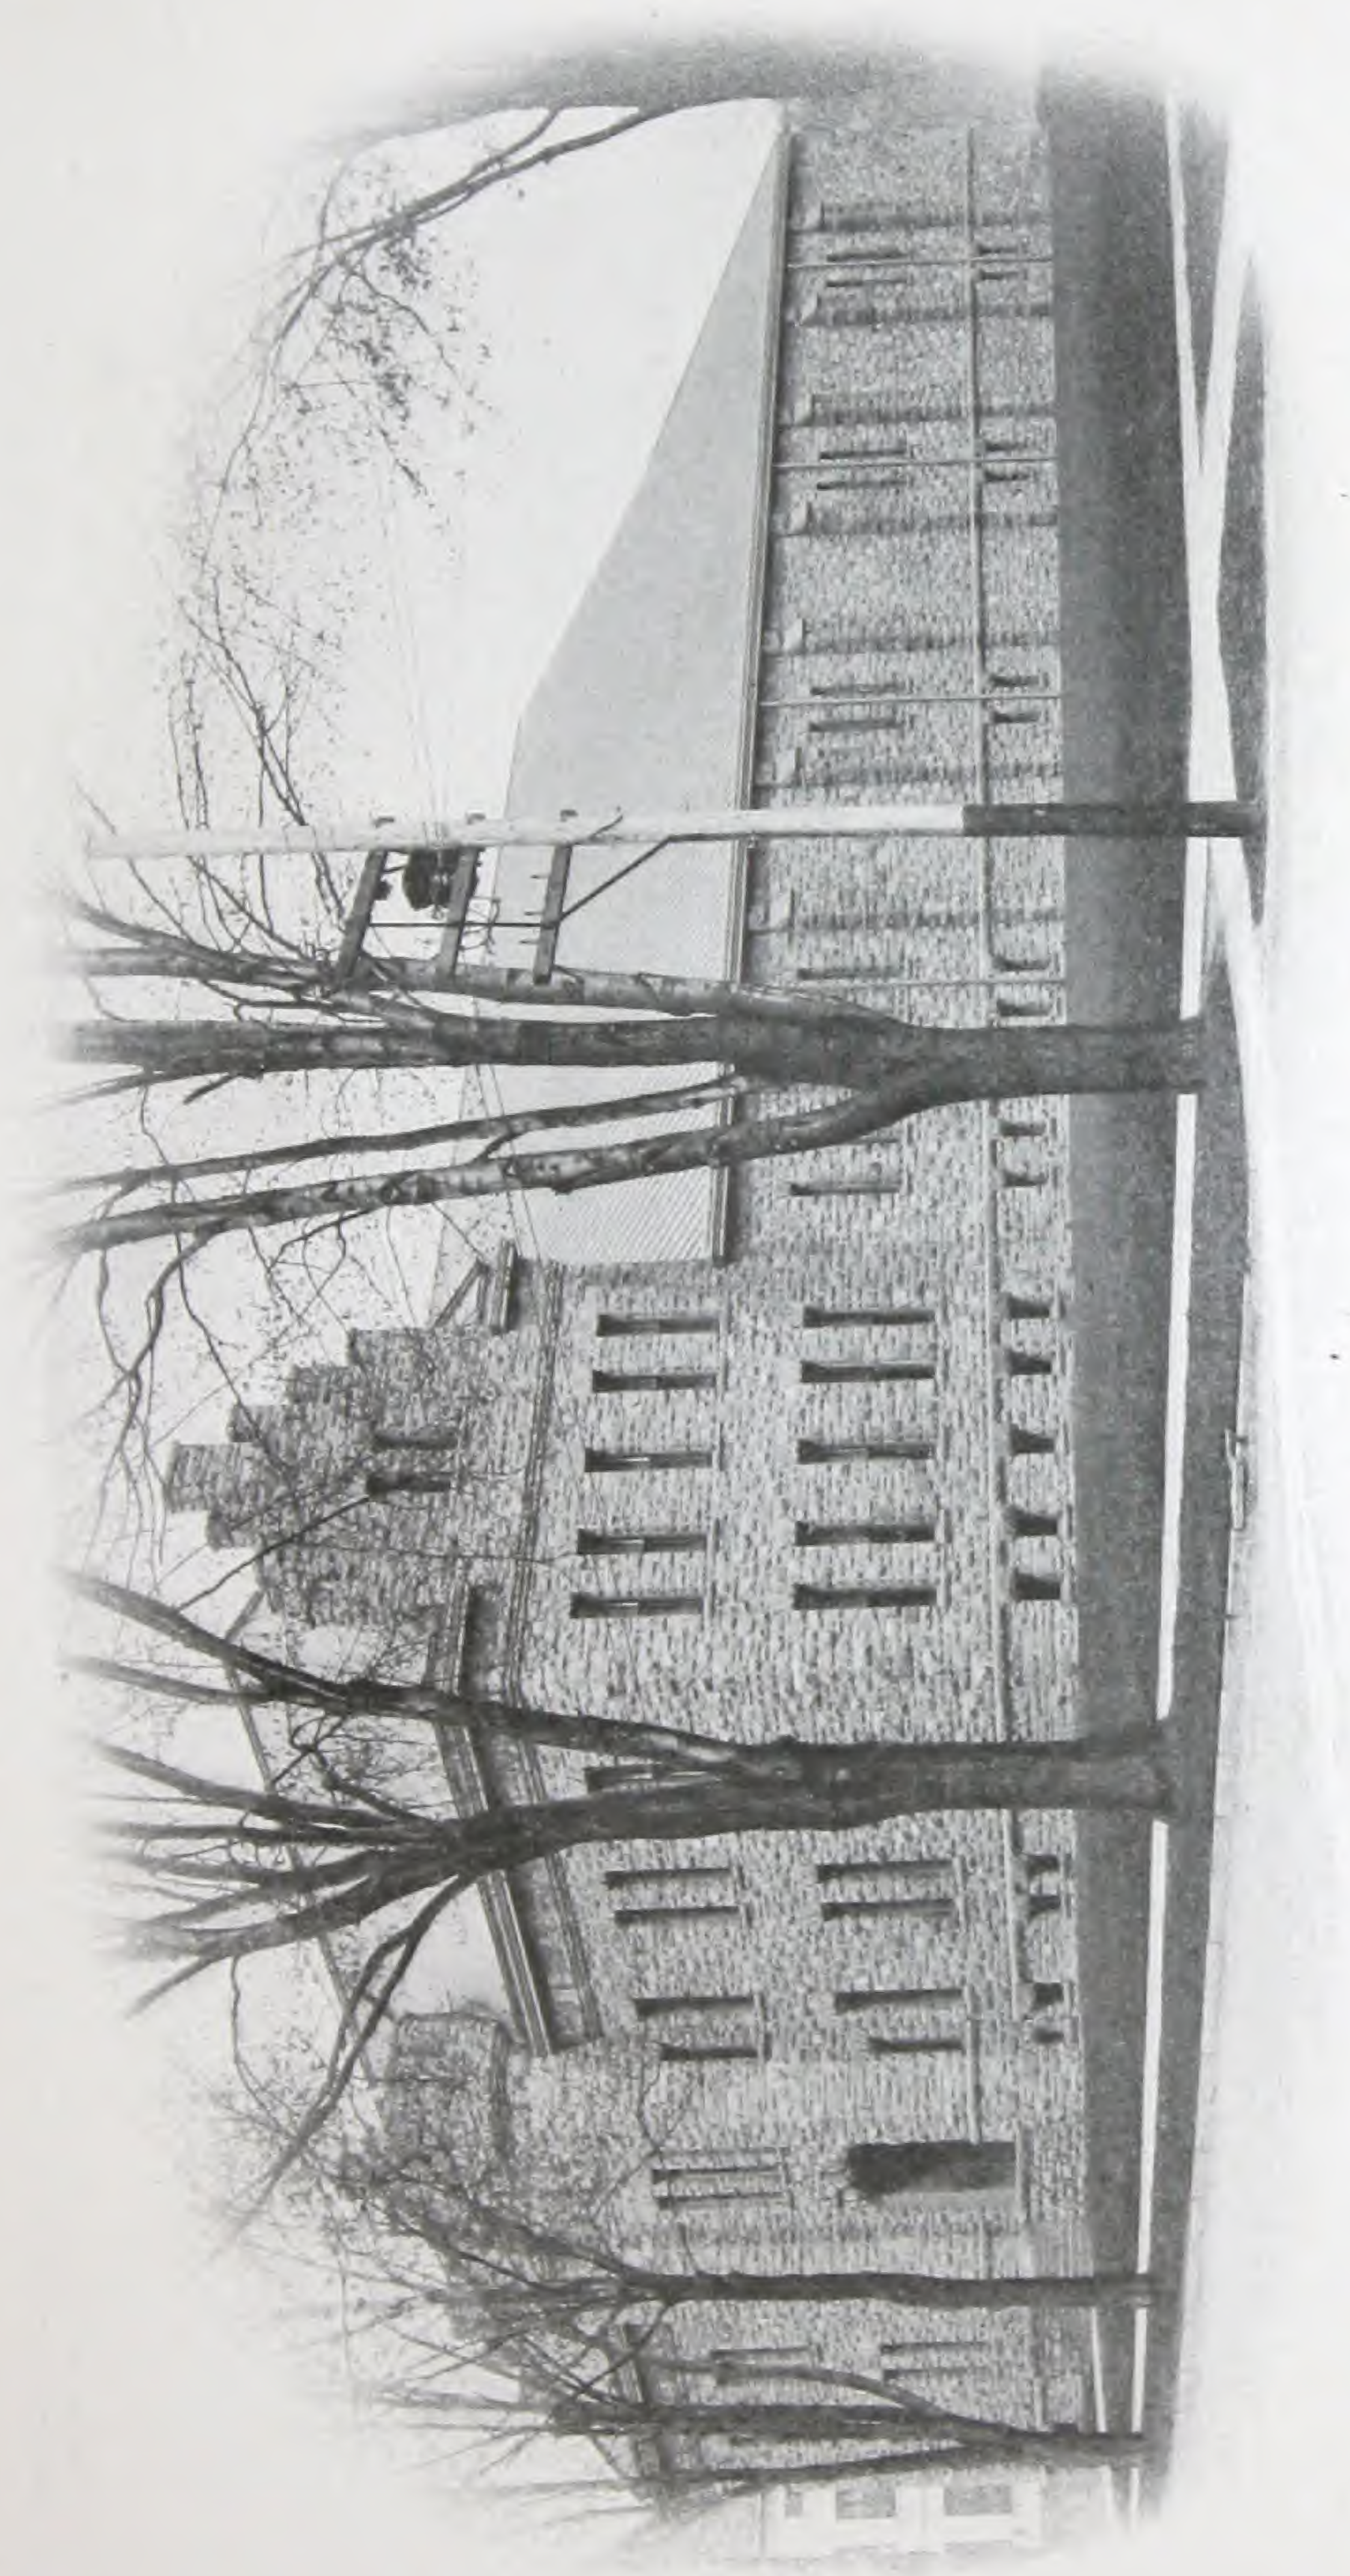
STATE ARMORY, MEDINA, N. Y.

Roofed with 10,000 square feet Target-and-Arrow tin. A good example of the use of tin to cover a large expanse of roof.

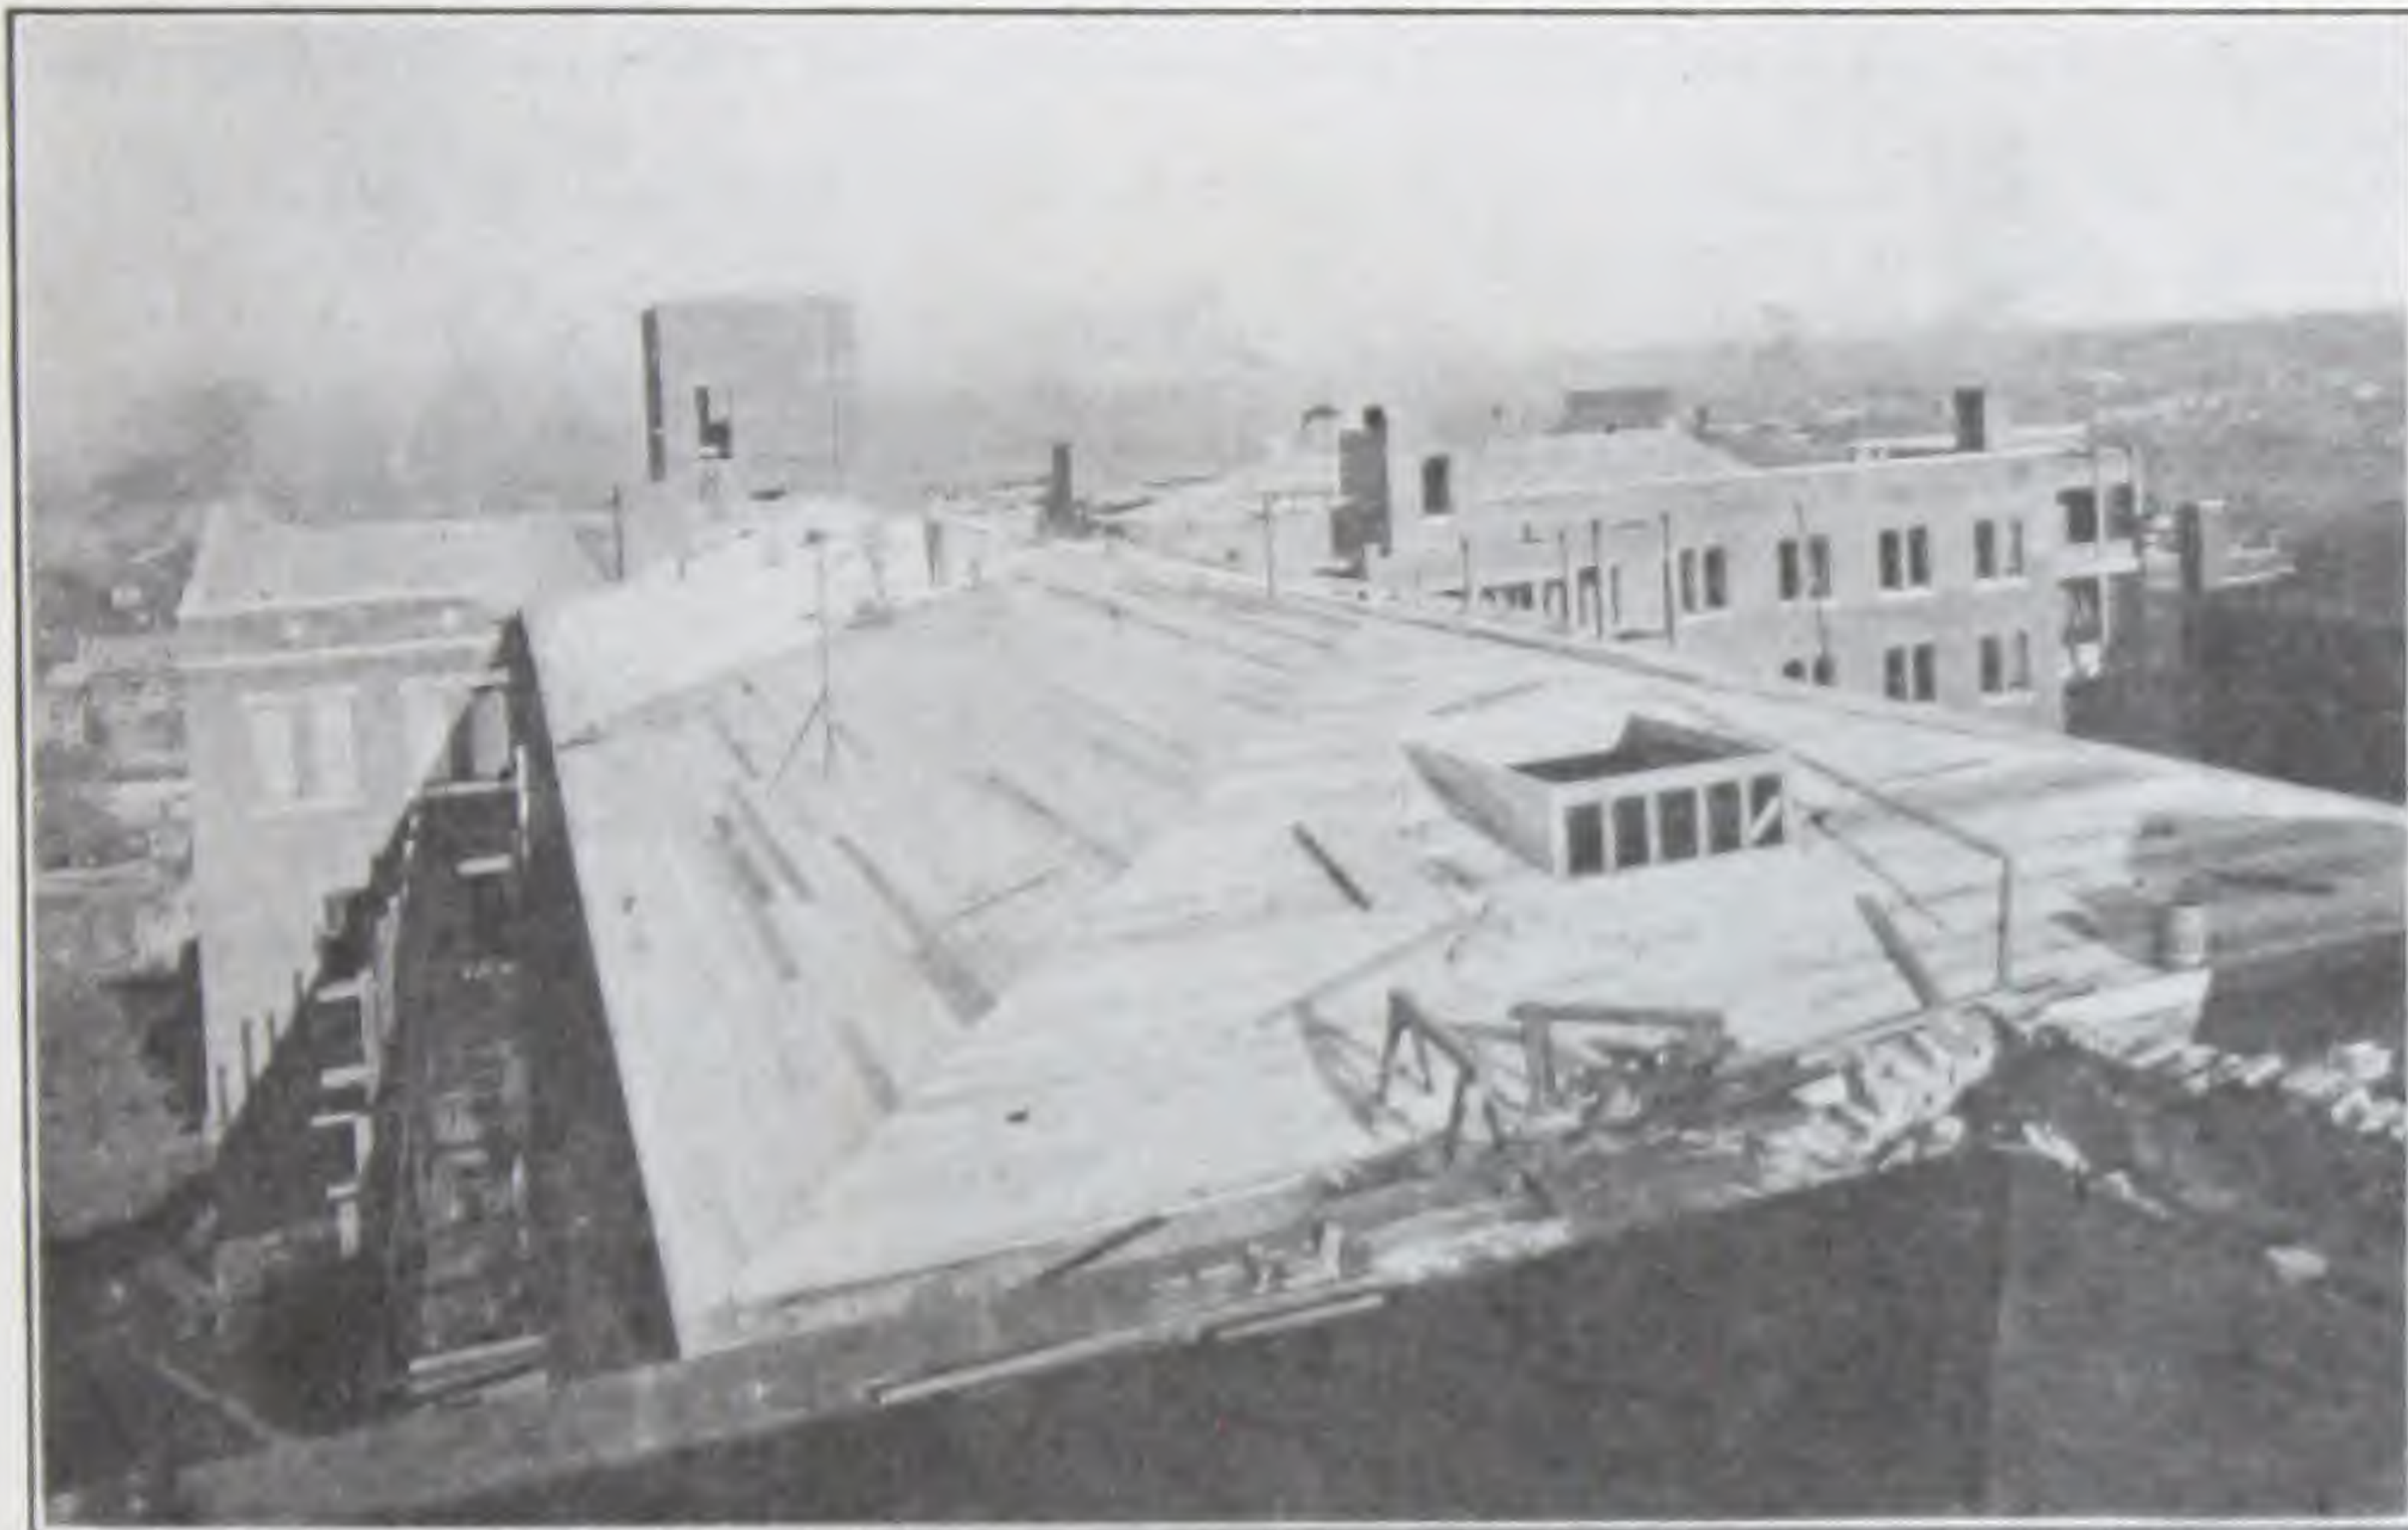
**19. RE-USE, OR SECOND-HAND VALUE:** In making improvements to St. Margaret's Hospital at Kansas City, Mo., it was necessary to remove a considerable portion of the old roof of our tin put on in 1884. The tin was found to be in perfect condition, and met ready sale at \$8.00 per square for use on other buildings. The same make of tin was used entirely for a new addition to the building.

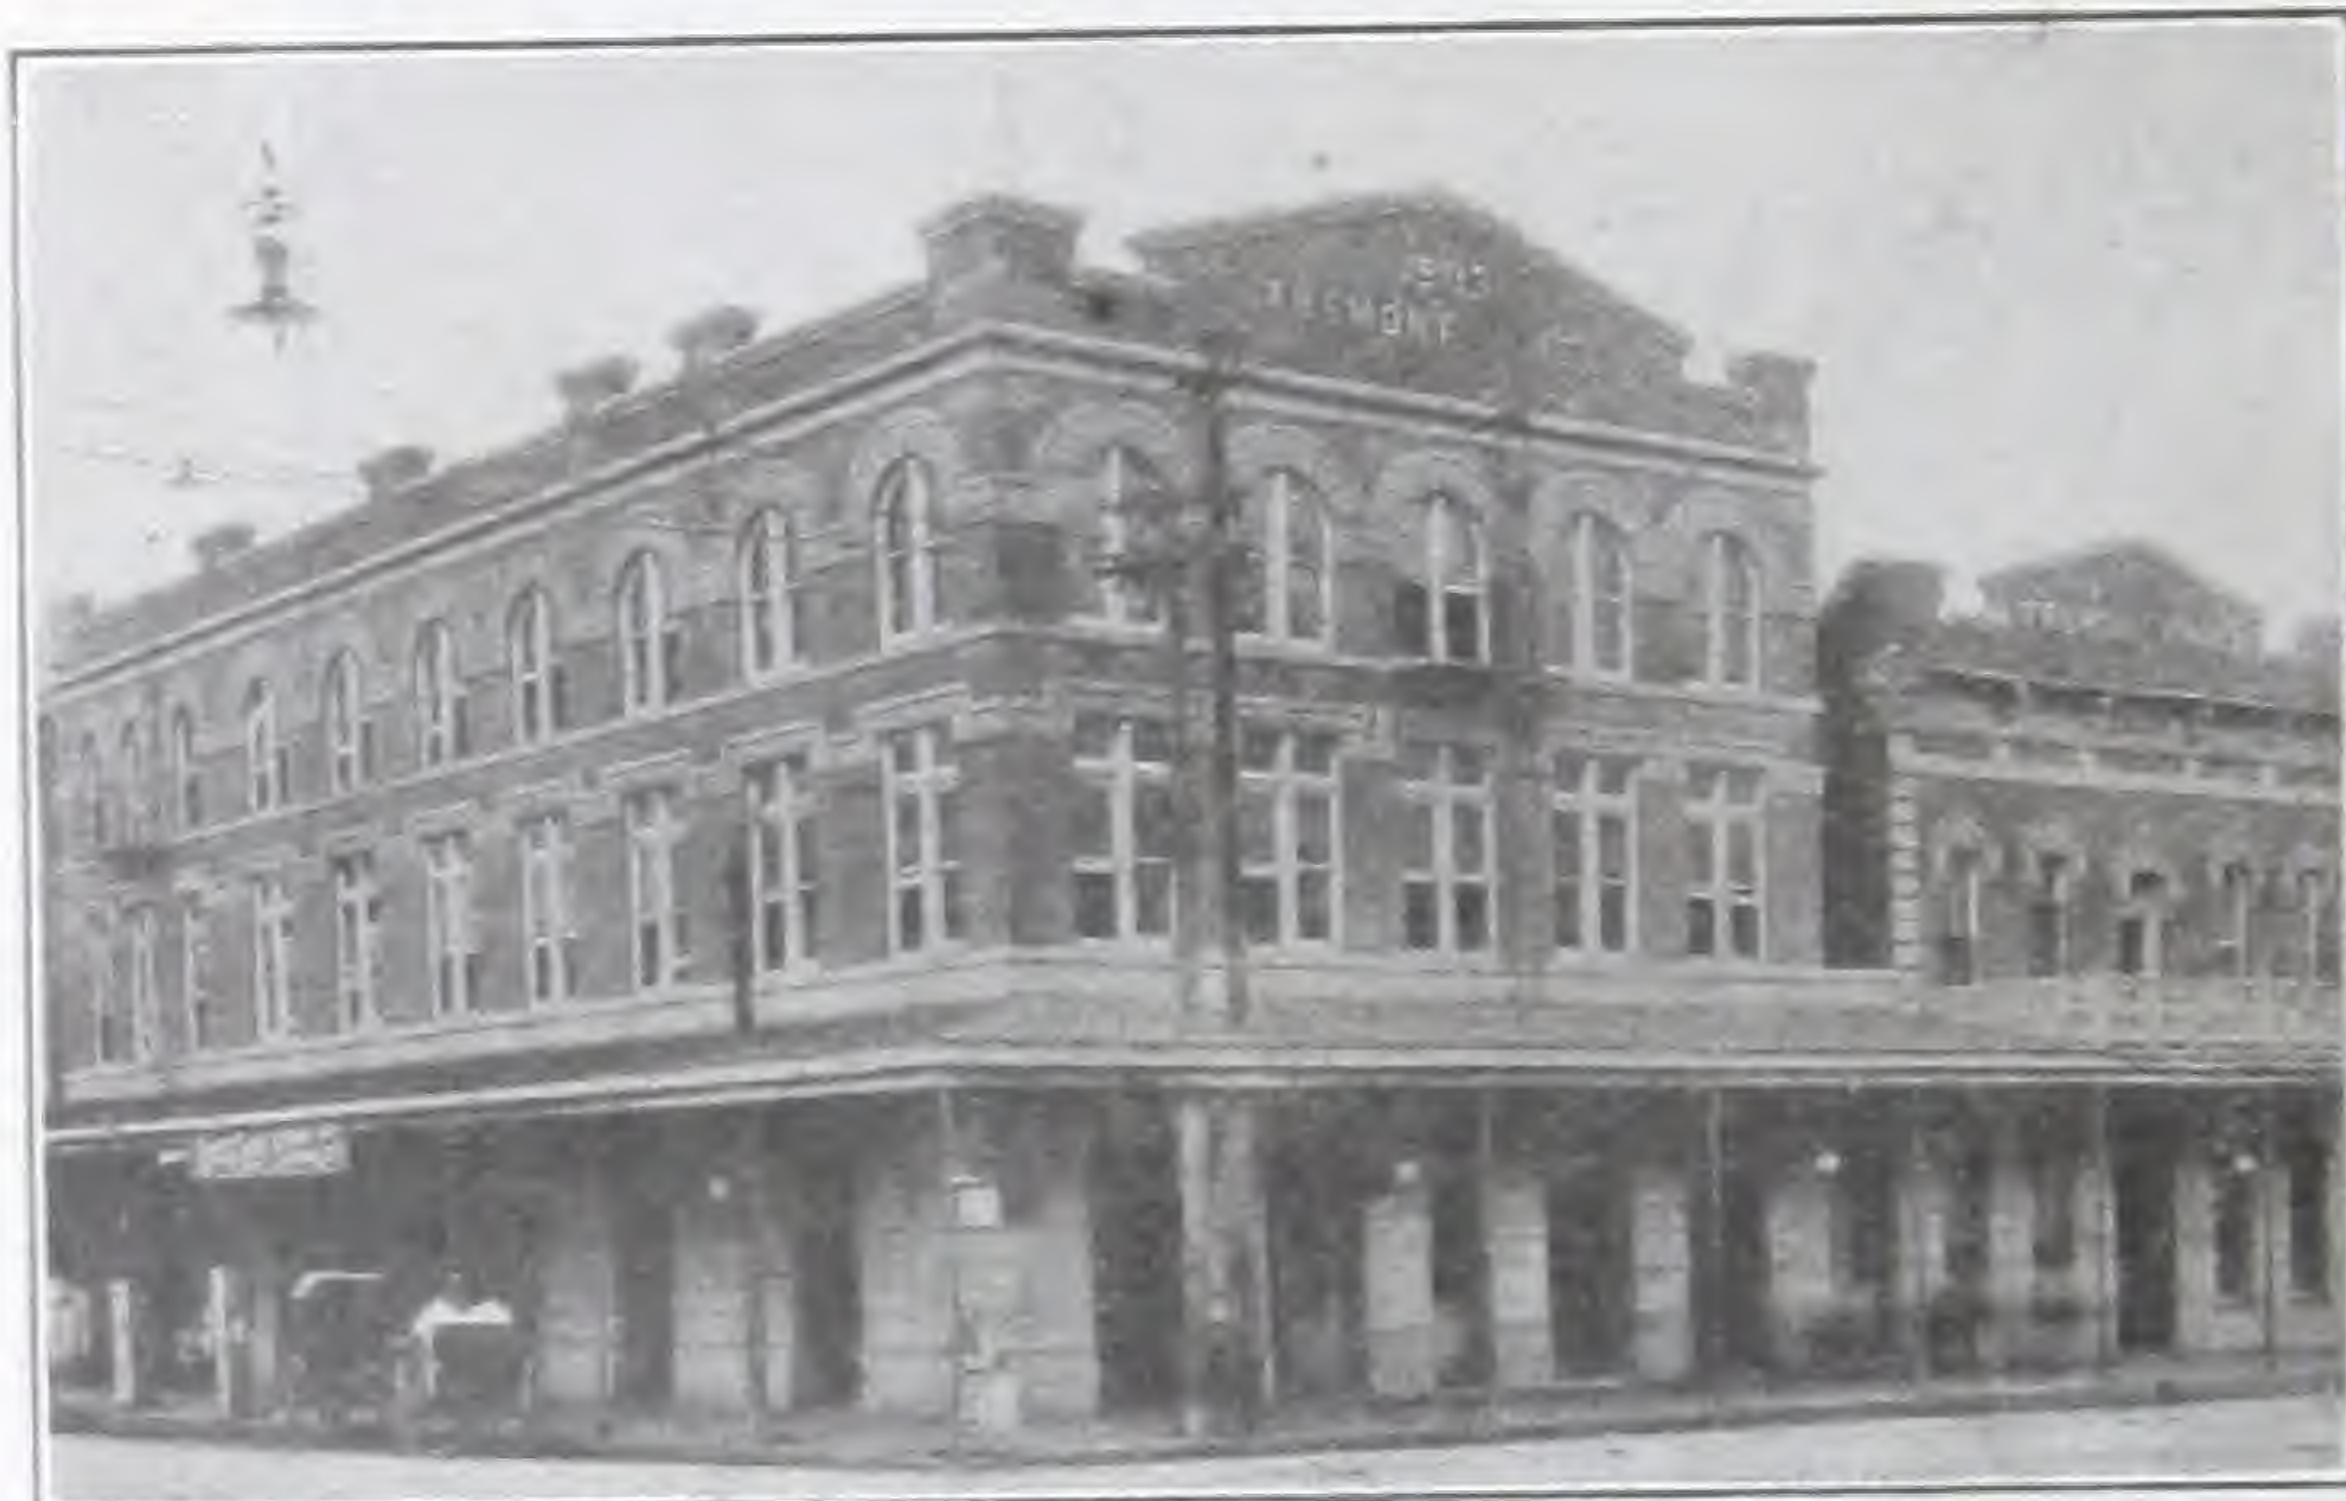
**20. RE-USE, OR SECOND-HAND VALUE:** The Tremont Hotel, at Houston, Texas, was remodeled in 1903. The original building was covered with our tin, put on in 1873. When the old building was torn down the tin roof was found in such perfect condition that it was carefully taken off and relaid on the new building. This tin remains in as good condition as it was 38 years ago.

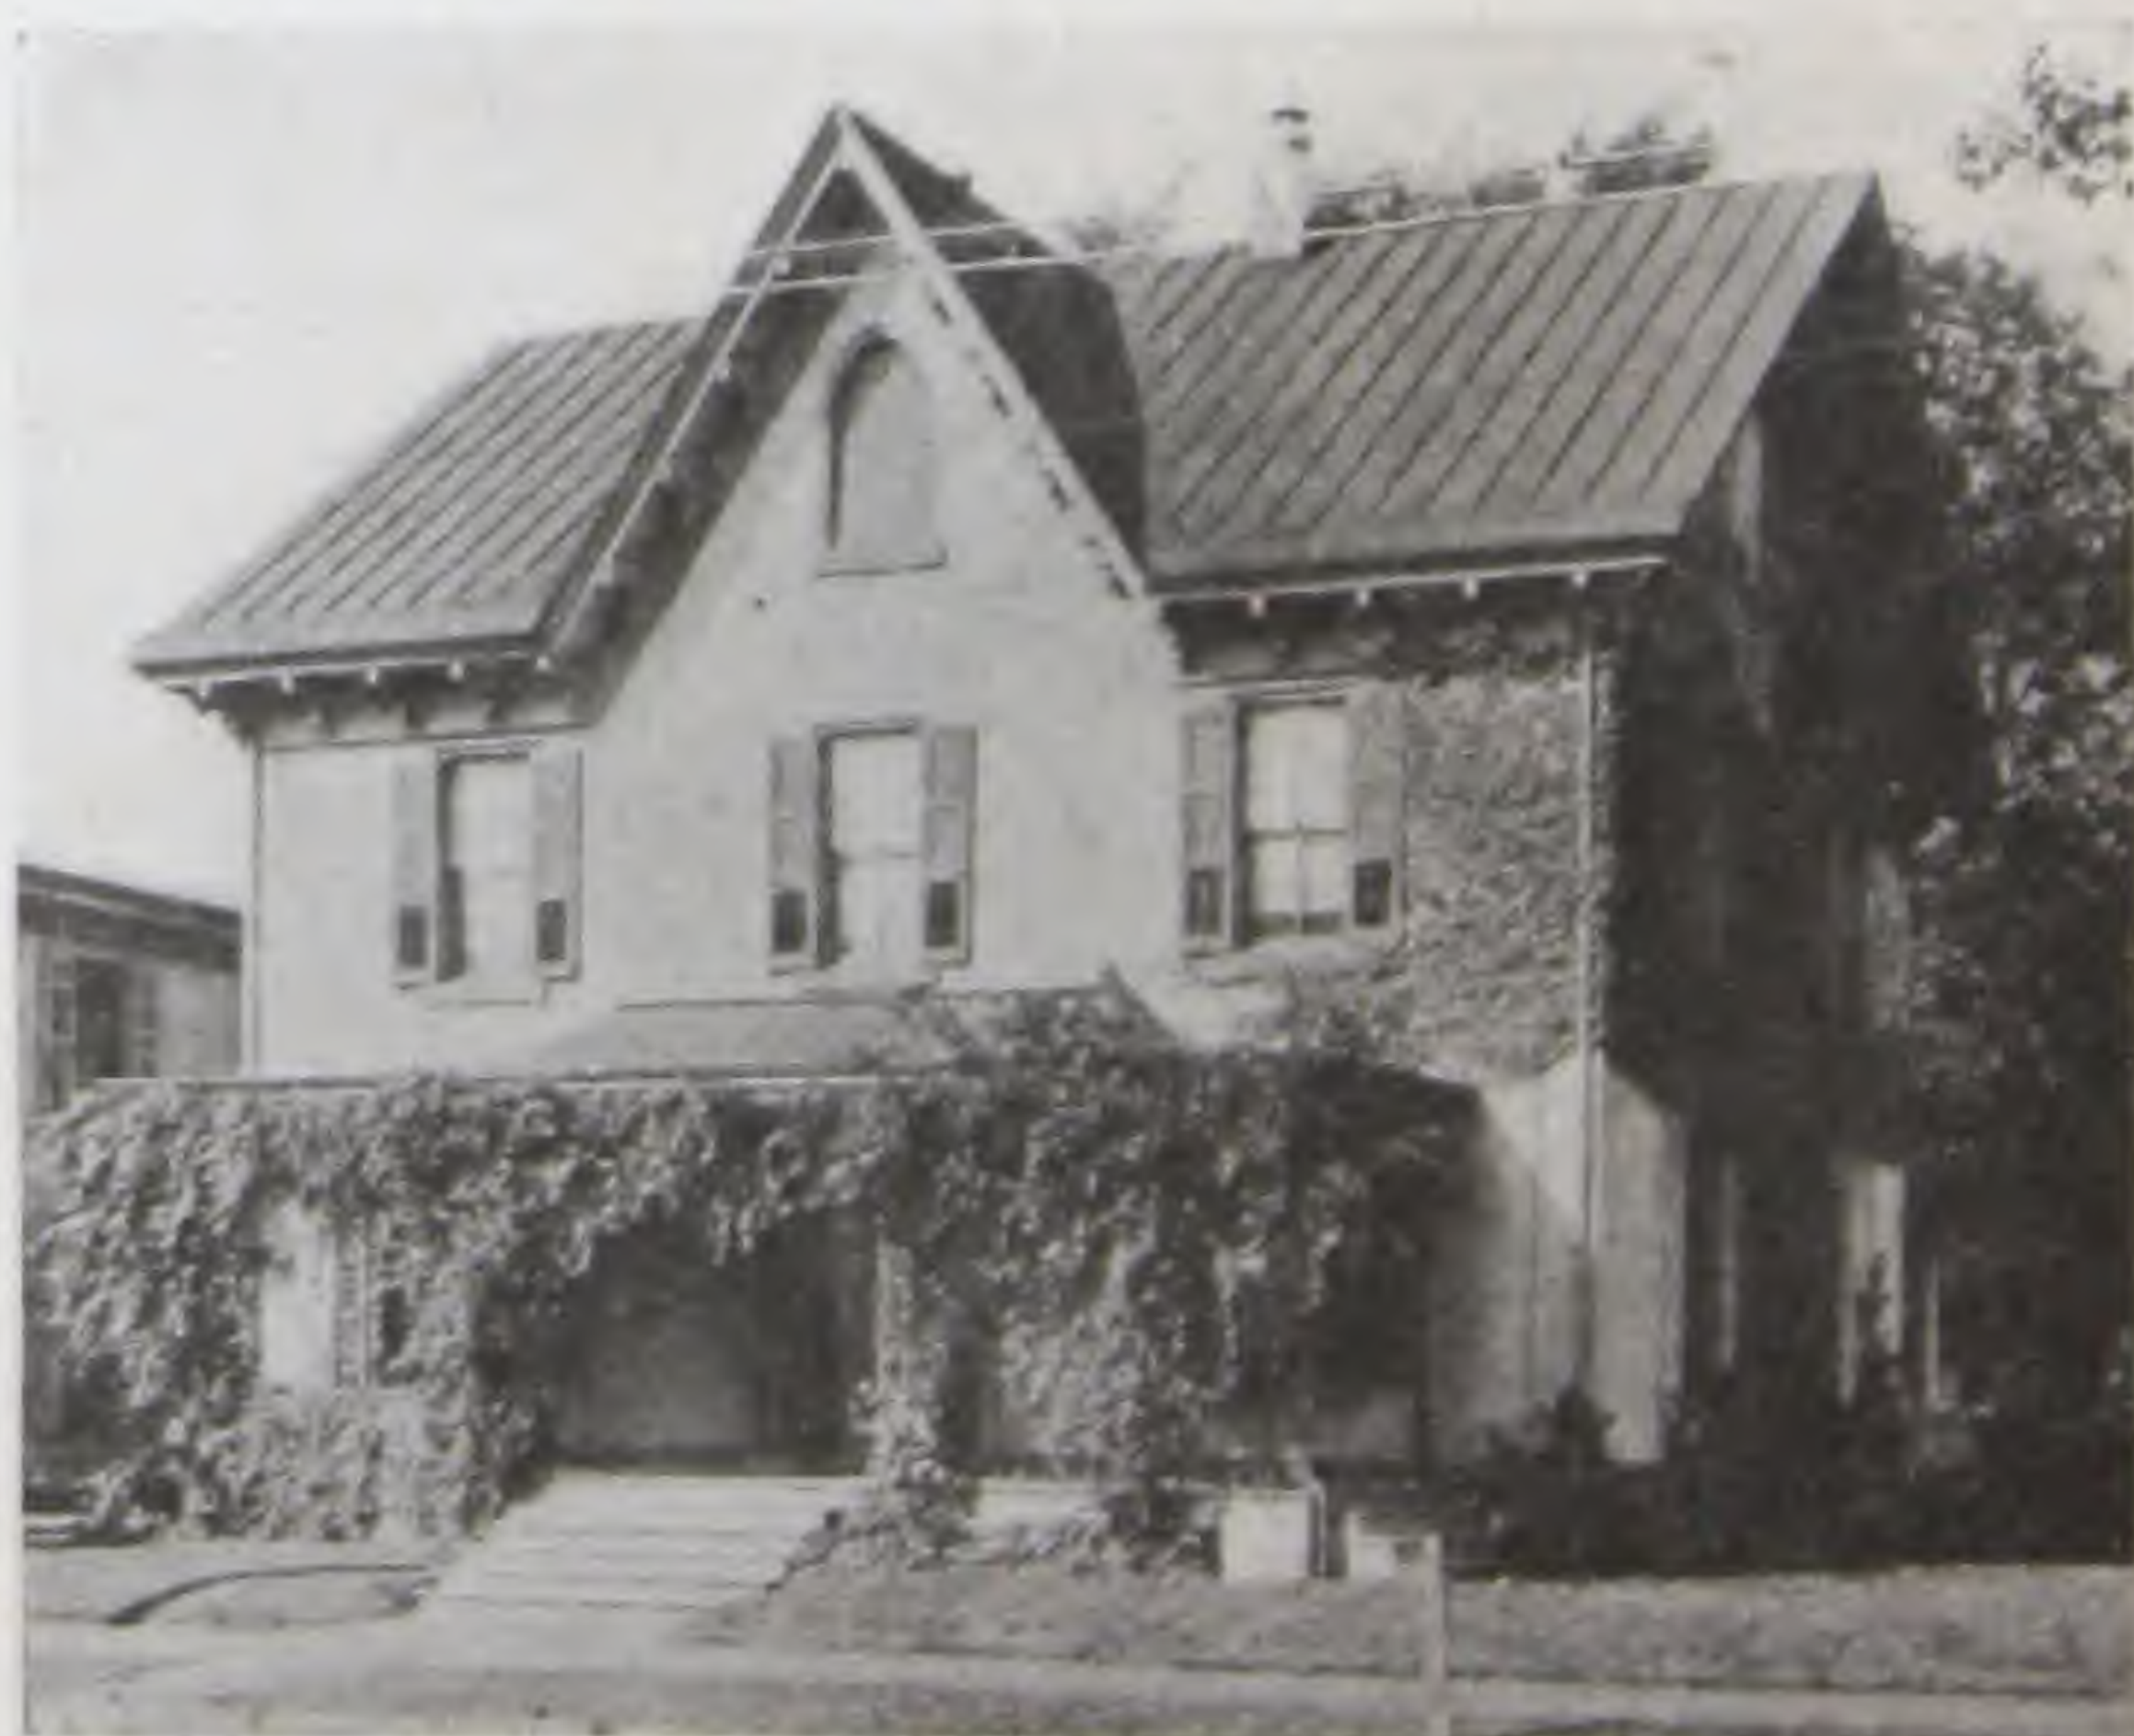
**21. APPEARANCE:** This old residence at Moorestown, N. J., was roofed with our tin in 1853—57 years ago. Age has had no effect upon the appearance or the value of this roof.

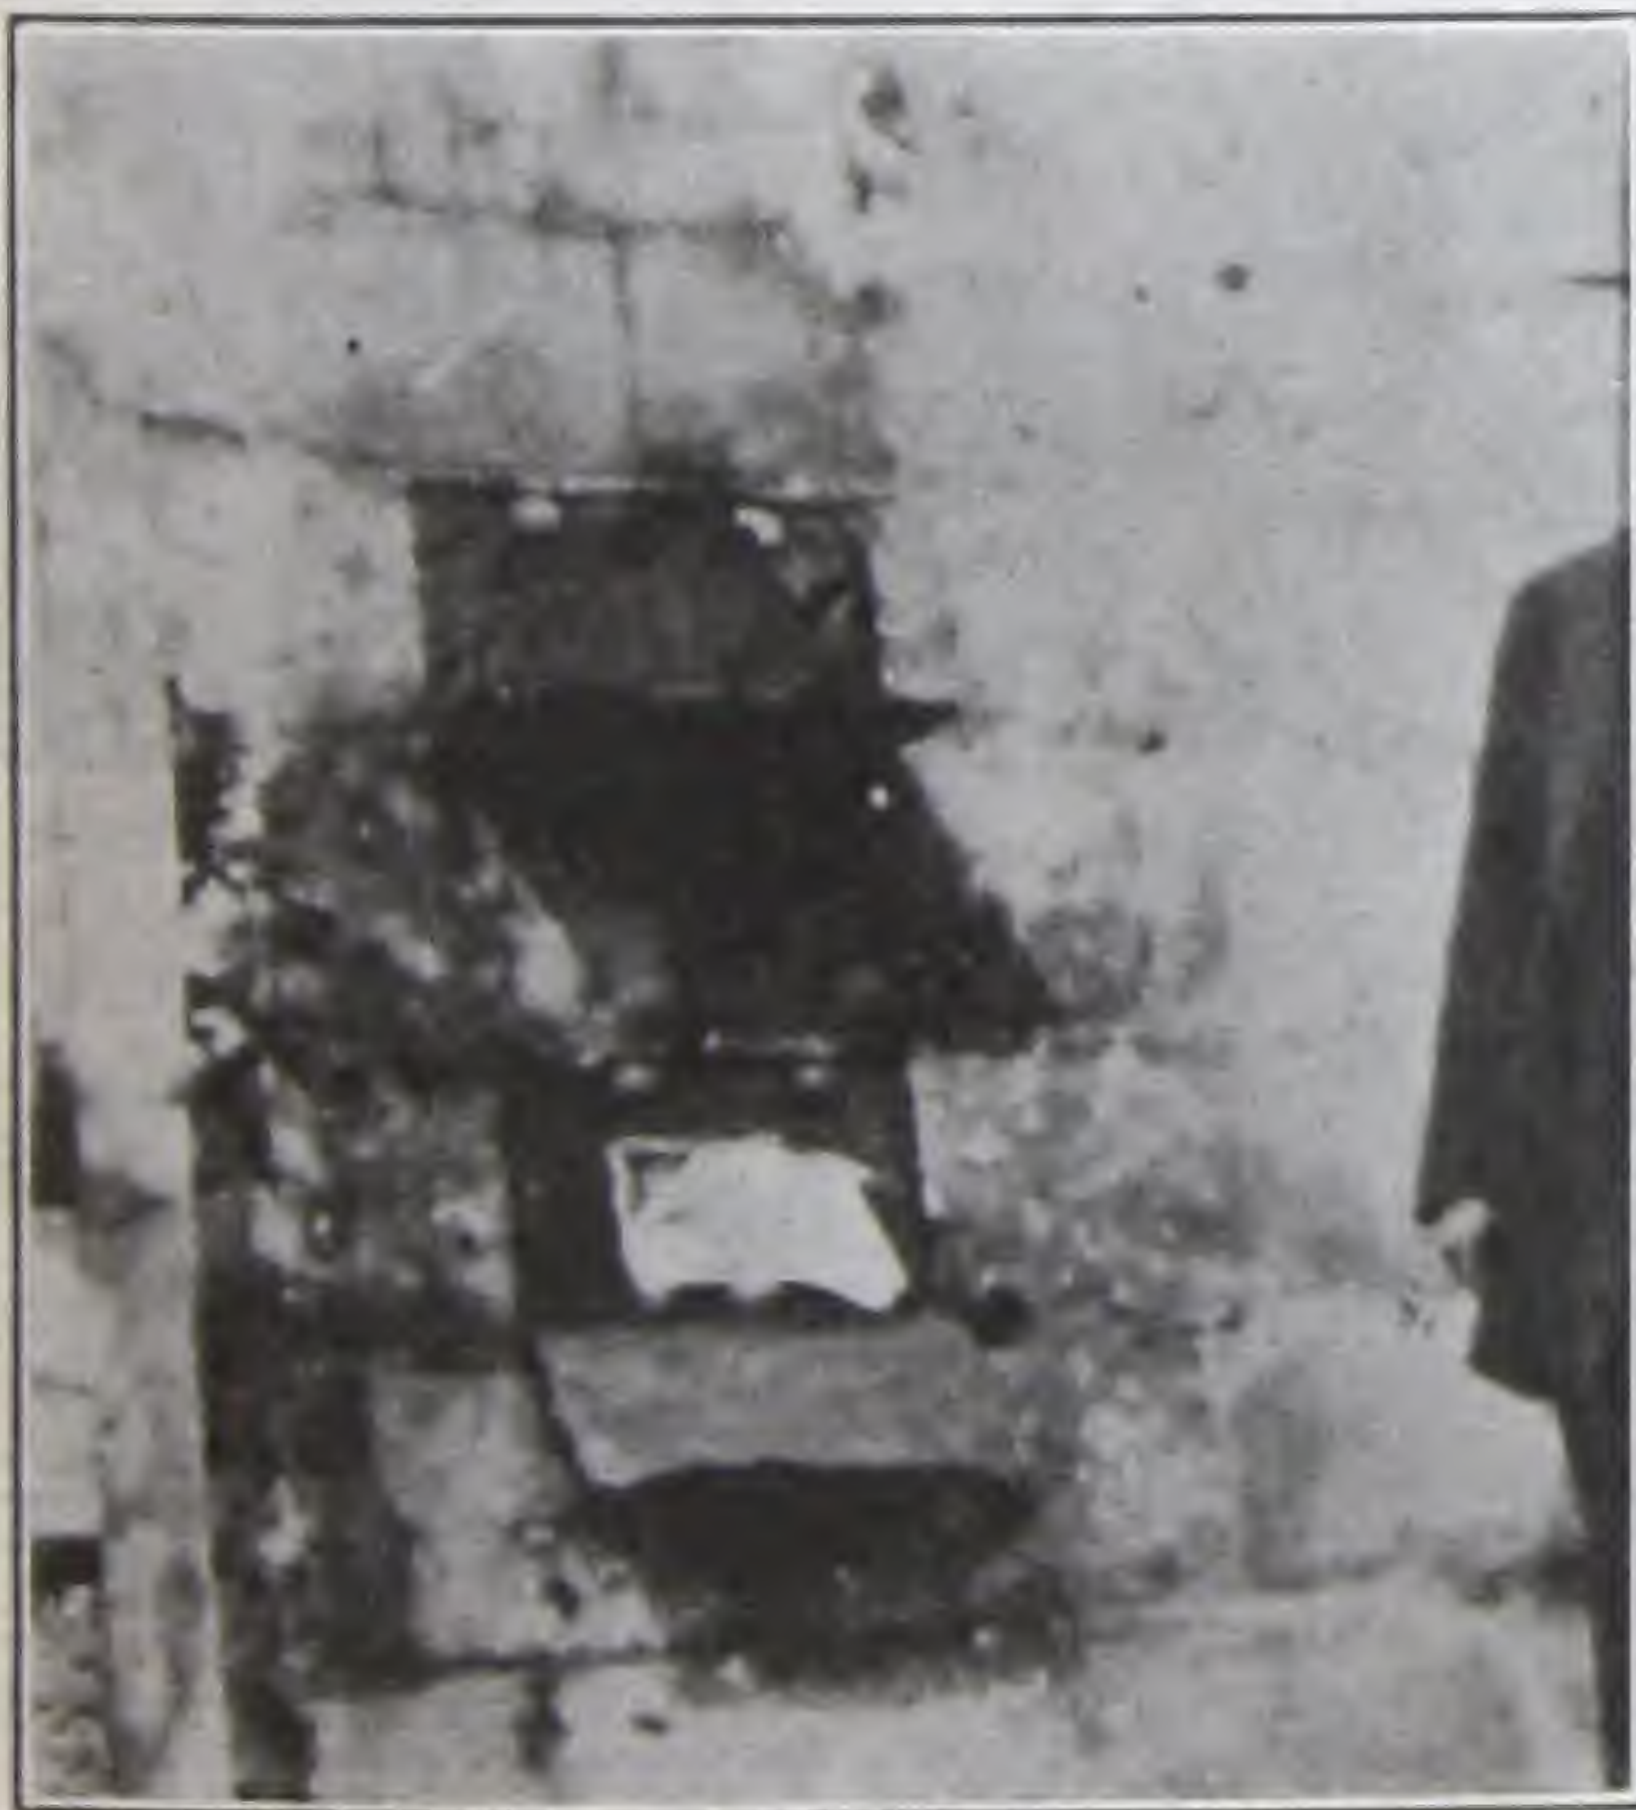
**23. FIRE TEST OF TIN ON ASBESTOS SHEATHING-PAPER:** Showing a section of the roof cut open after the test. The sheathing-boards were found uninjured. The deadening-felt had crumbled under the heat, but the asbestos paper remained in perfect condition. The tin was blistered and discolored by the intense heat, but easily withstood the fire.

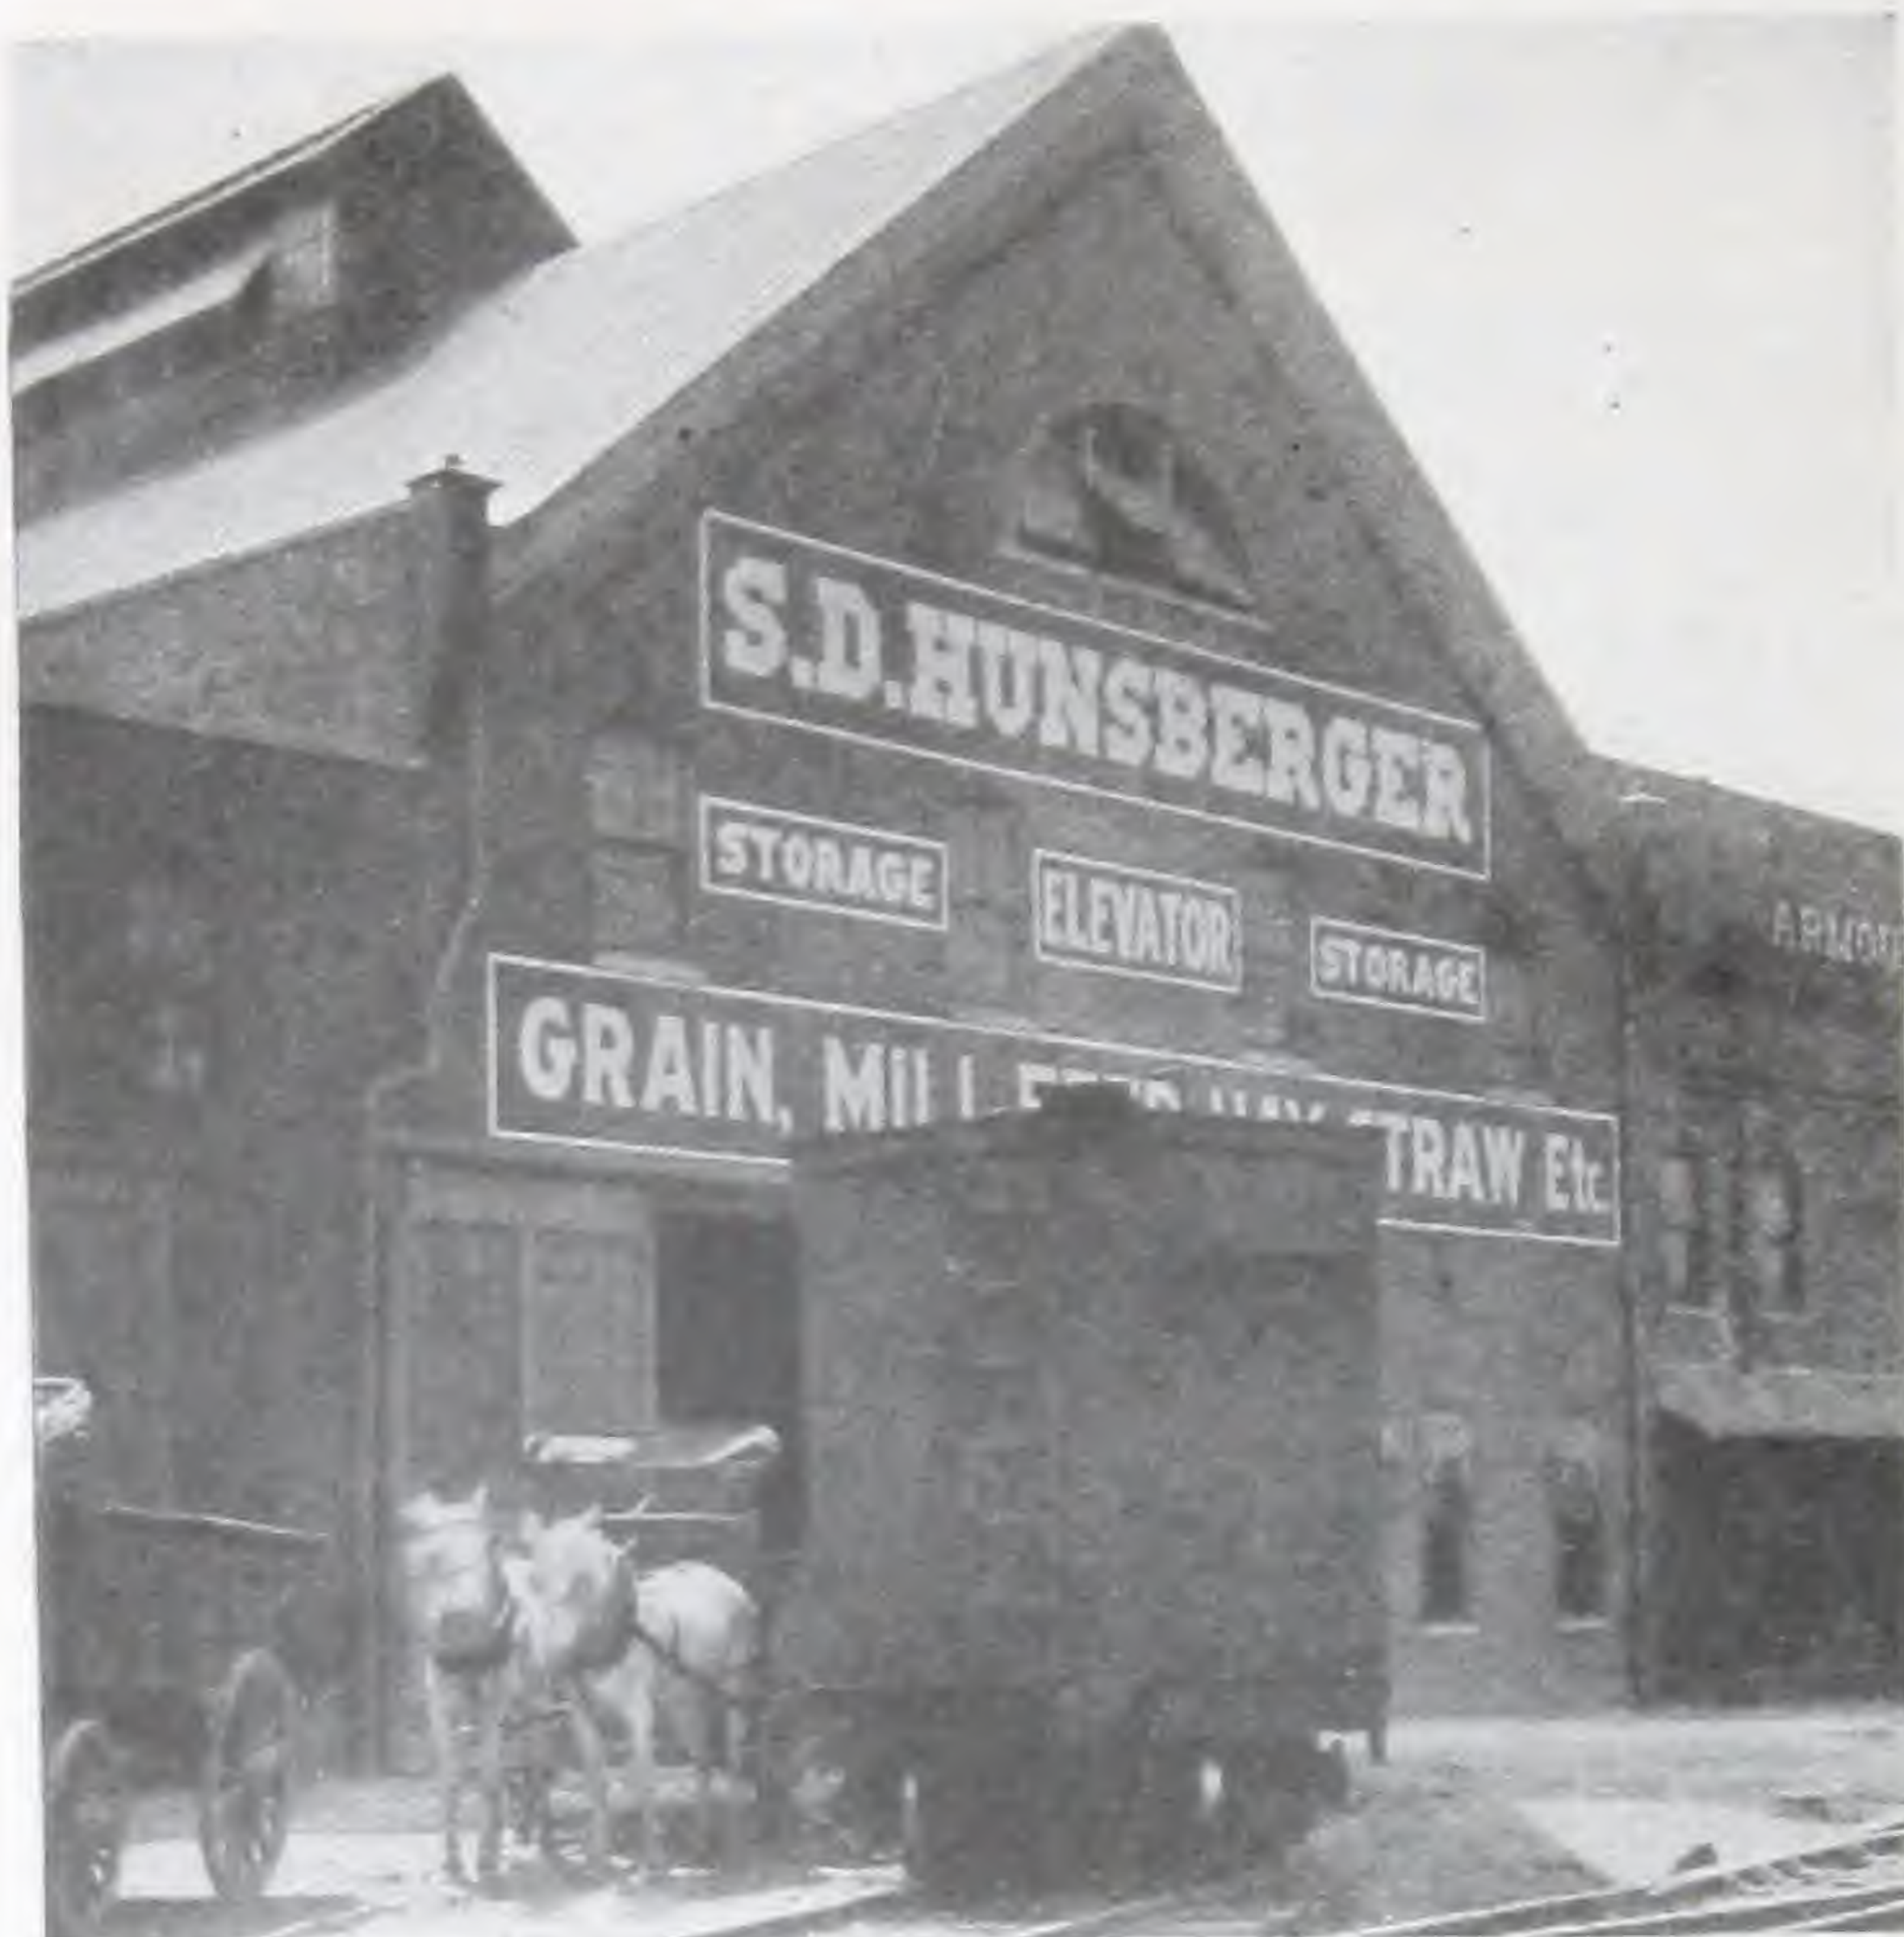
**24. PROTECTION AGAINST FIRE:** The Hunsberger warehouse building on North American Street, in Philadelphia, containing such combustibles as grain, hay, straw, etc., has had a severe test of exposure to fire. The adjoining building was burned twice in 1906. At both times the wind carried the flames against the warehouse roof, but the tin roofing successfully withstood the attack, and each time only a coat of paint and the soldering of a few seams were required to put it in good condition.
